THE VINTAGE ADVANTAGE

News Items for Vintage Airstream Owners & Admirers

Spring 1998

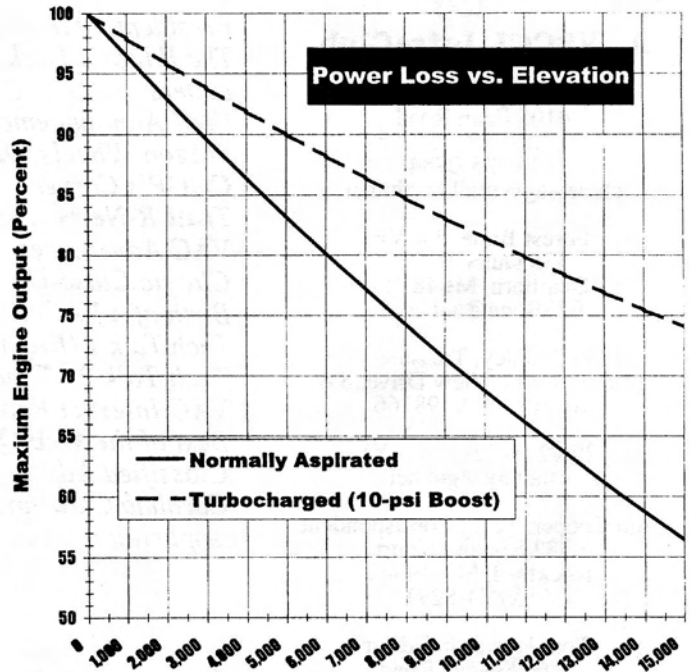
Recently this point was brought home in a "Tech Talk" article appearing in the *March 1998* (p. 107-8) of **Car Craft** that was accompanied with a graph (reprinted below). The graph shows the percentage of maximum engine output as a function of elevation for both a normally aspirated engine and a turbocharged engine (with a 10-psi boost). As reprinted in the graph below, note that at 10,000 feet (comparable to crossing the Rocky Mountains near Denver), a normally aspirated engine is reduced by 32%!

This helps explain why my performance is limited at elevation (although I am within the van GCVW) but I am still wondering why the octane levels at gas stations out west are less. Any reader comments or insights?
