AIRSTREAM

THE DURA-FLEX Rubber Torsion Axle GKN (Henschen)

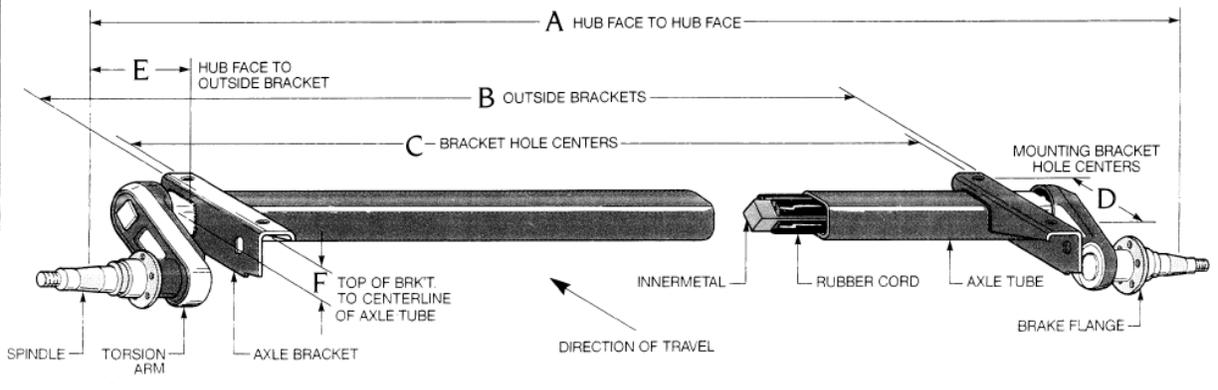
Checking your Axle

The correct way to check the angle of the arm is under a "no load" situation. Jack the trailer up off the ground and check the angle. If the arm returns to a below horizontal positions under "no-load" it is function correctly. The position of the arm under a "load" situation is dependent upon the weight of the trailer. The more weight the more above horizontal the arm will ride.
